T-576

Captain's Cabin

Architectural Survey File

Maryland Historical Trust State Historic Sites Inventory Form

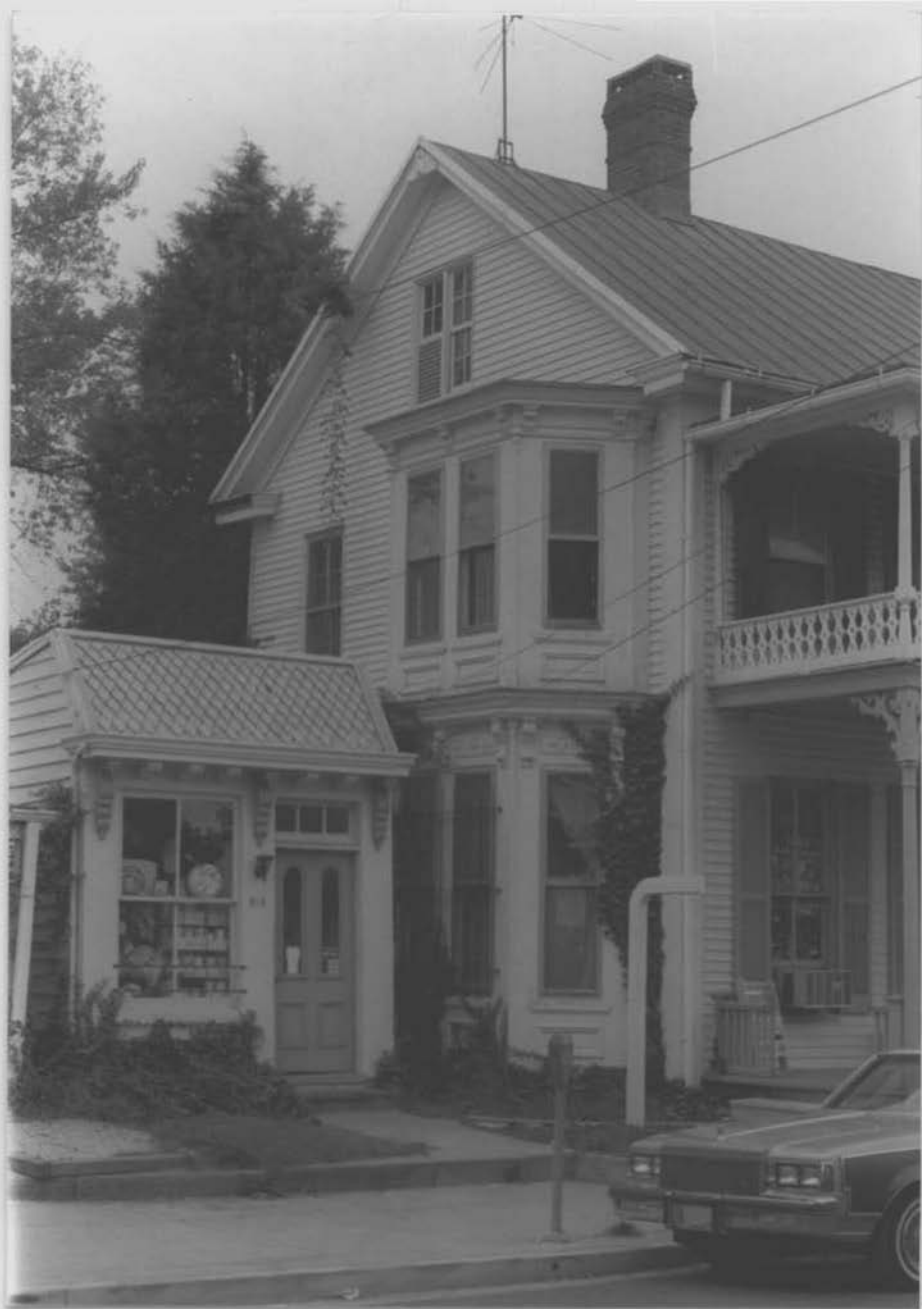
South Gable End

The south gable end is two bays deep. The east bay is distinguished by a two-story bay window that is lighted by single-pane sash windows. Below the first floor windows the knee wall is paneled, and above the first floor windows the space is filled with decoratively incised panels. A mid-level cornice with brackets divides the first and second floors. The second floor cornice is treated with brackets as well as applied trim. Four over four sash windows fill the west bay, and paired four over four sash windows illuminate the attic. The extended eaves have short

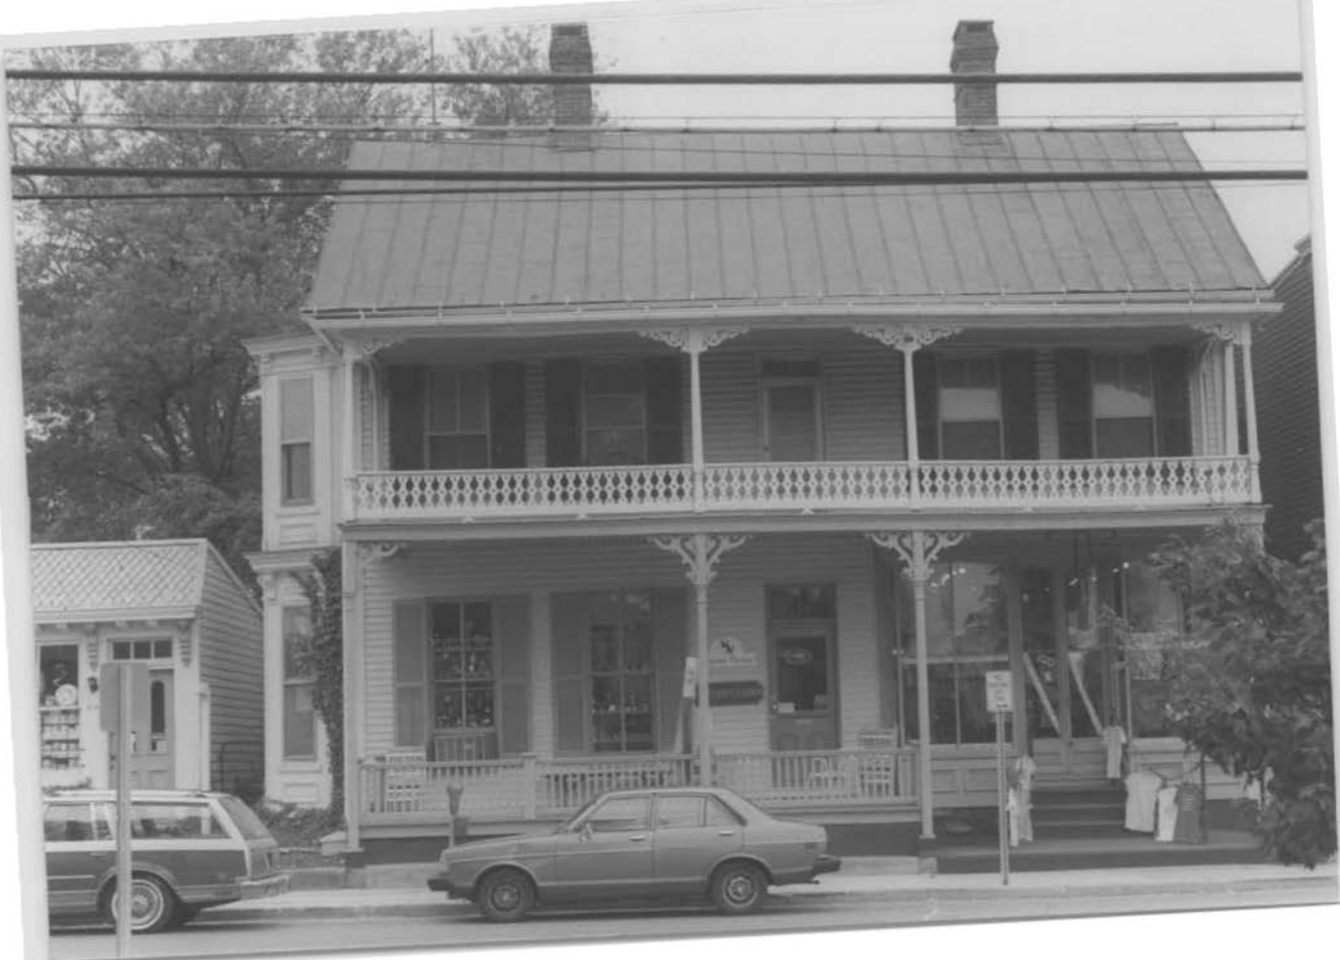
East Elevation

The east (main) elevation is five bays across with a center entrance and flanking windows. The north bay is marked by a separate storefront with large glass display windows and a recessed double door entrance. The knee wall below the windows is paneled. The main door is glazed and topped by a two-light transom. Piercing the south wall of the first floor are two four over four sash windows flanked by louvered shutters. The second floor is marked by a center door and flanking four over four sash windows. Covering the entire front is a two-story porch supported by iron posts on the first floor and turned wooden posts on the second. Decorating each post are sawn brackets and stretching between the second floor posts are sawn balusters.

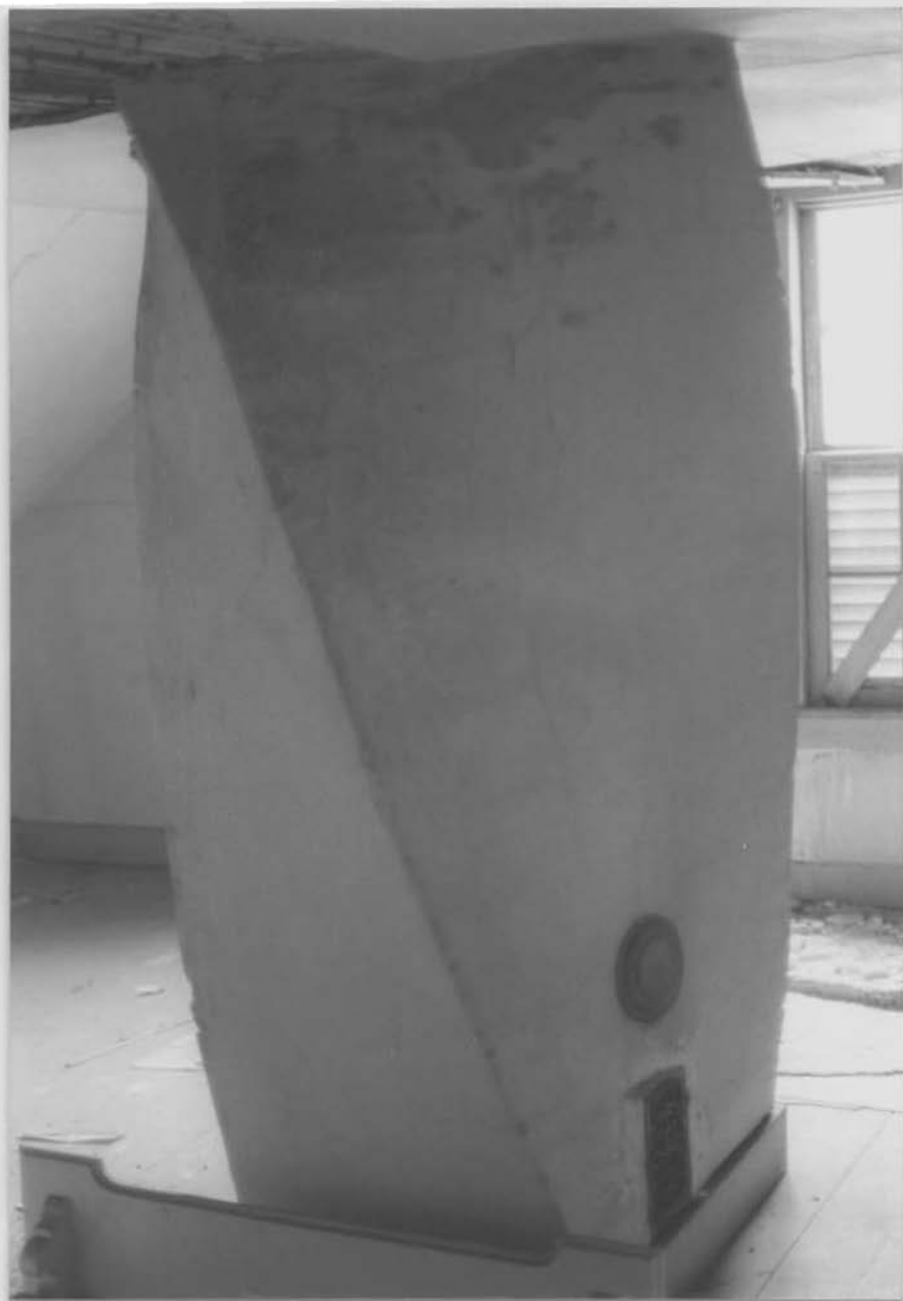
Chimney Stack

The attic is divided into two rooms which flank the center passage. The rarest feature is the twisted brick chimney stack that rises through the south room. The large brick stack was built with forty-five degree twist so the stack protrudes through the roof in the same manner as the straight north stack.
